Roof to Sidewall Joint Sealing

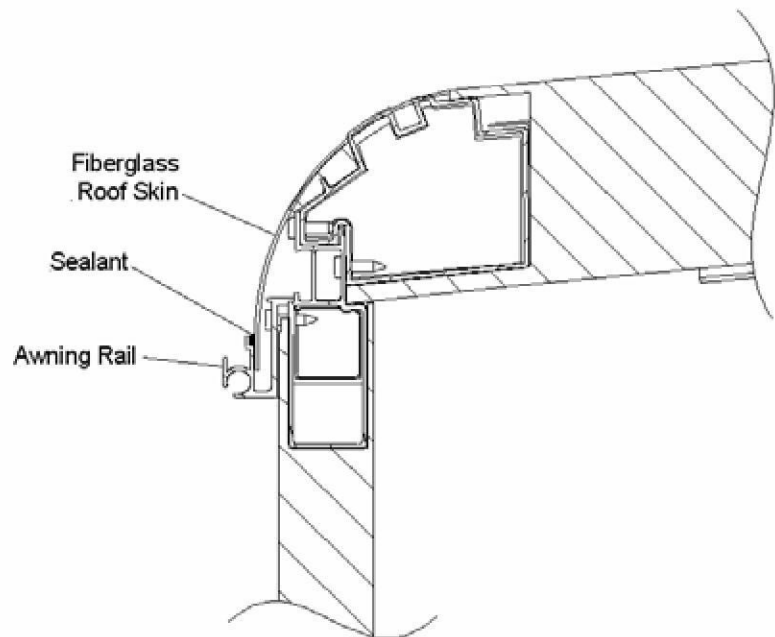
This month we want to remind you of the importance of regular inspection and maintenance of the seam between the roof skin and awning rails on your Winnebago Industries, Inc. motor home. We suggest that you carefully inspect this seam twice each year. A proper inspection requires that, in addition to a visual check, you lightly push against the skin at the seal to ensure that it adheres to the awning rail channel. Any areas where sealant is missing or the adhesion is broken will require removal of the ineffective sealant, thorough cleaning and preparation for new, and careful application of the recommended product. The following is an excerpt from a service bulletin to our dealers which addresses this process.

1. For all units ensure the fiberglass skin is free of contamination. Clean aluminum trim and fiberglass thoroughly with rubbing alcohol.

Note: If silicone sealer was used to seal roof to sidewall joint previously, the silicone needs to be thoroughly removed so the urethane will adhere to fiberglass and aluminum trim.

2. For units **without** over the roof paint, cap seal the roof fiberglass and trim with 072889-10-000 bright white urethane.

3. For units **with** over the roof paint, cap seal the roof fiberglass and trim after painting with 094401-04-000 clear sealer.

The part numbers for the sealant are for tubes that will work in a standard caulking gun.
